Reference: 15-05-0071

Chalmers United Church  
842989 Road 84,  
Kintore, ON N0M 2C0

**RE: CONDITION ASSESSMENT**

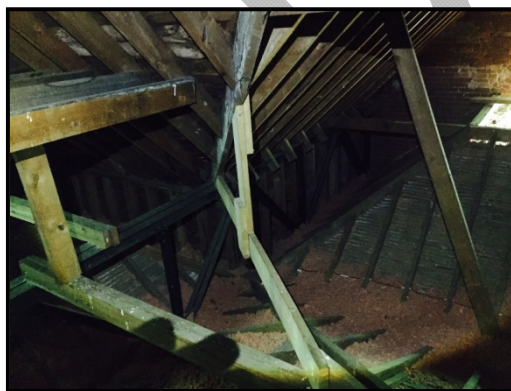
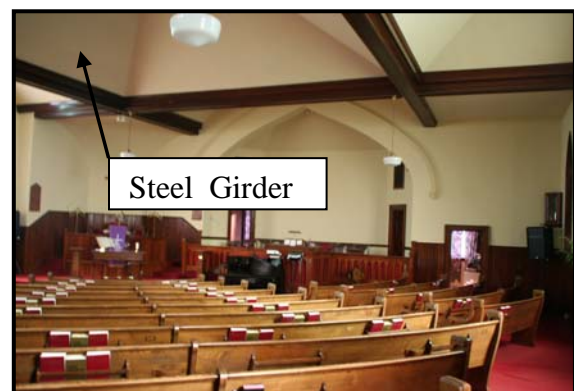
With regard to the attic space, it would appear that the side aisle additions were made since the original construction. There are riveted steel girder trusses full length of the church on both sides likely replacing the original side walls and pilasters. We noted significant sagging of the roof from the exterior. There are signs of distress at the support piers at the north end.

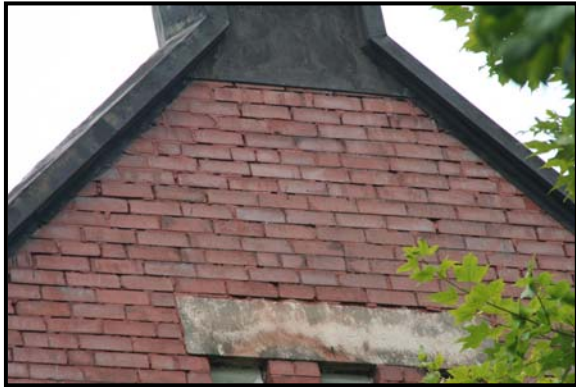
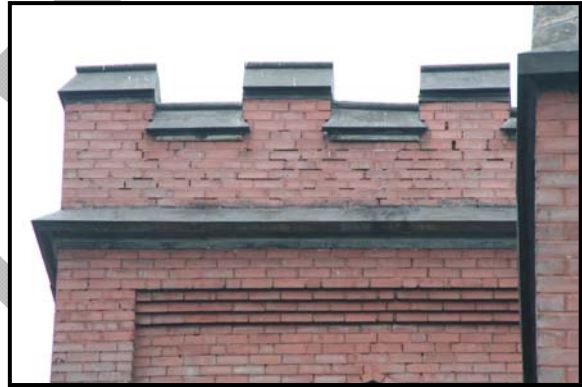
With regard to the exterior masonry, the exterior is comprised of red brick and has recently been partially repointed on the east wall. Areas requiring pointing include the east face of the tower parapet, the east gable and the area under the windows below as well as the west pilaster adjacent to the downspout and again, under the transept windows. The chimney, which is not being used, is in poor condition and should be removed.

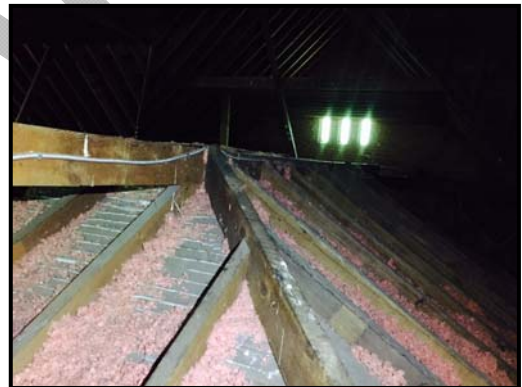
With regard to nave roof framing, there is significant curvature in the four main valley rafters as well as curvature in the top framing members for the both the top and the bottom framing members for the vaults. We also noted no insulation. There appears to have been loose insulation but the insulation has fallen down the slope to the valleys between the vaults. There is no bridging between collar ties. The plaster keys appear to be sound although it appears that drywall has been installed over the plaster surfaces. There are no mechanical connections from the rafters, valley rafters or support beams to the exterior walls or to each other.

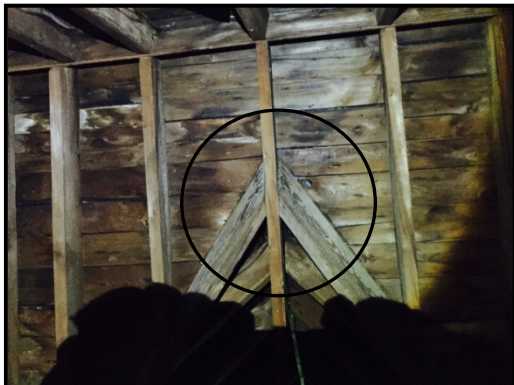
The valley rafters frame into a single roof rafter. The roof anchorage is accomplished by wood framing "hooked" over the steel girder.

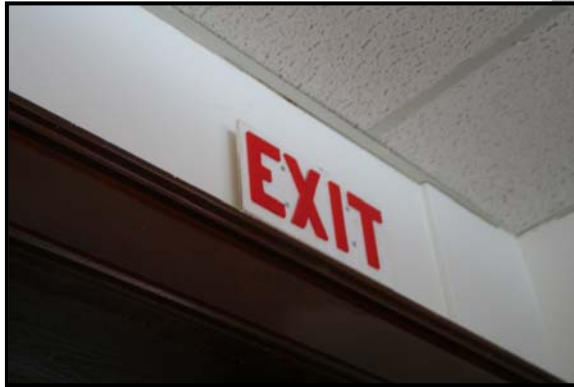
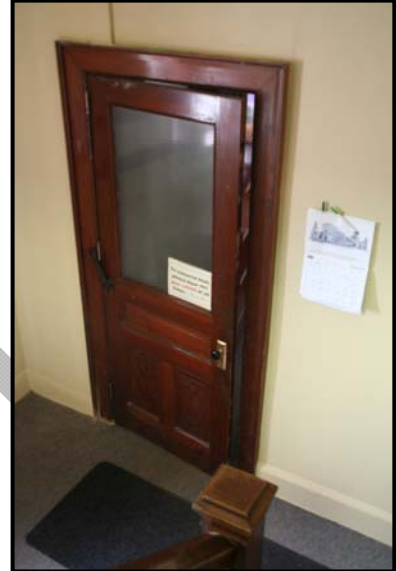
With regard to the basement, there is a full basement through the original and the additions including a hall, kitchen, washrooms and storage. The kitchen has a commercial stove with what appears to be a commercial hood but no fire suppression. The basement floor is approximately 4 feet below grade. The parish does not report any problems with water or moisture although a dehumidifier was running during our visit. Lack of air circulation is likely a contributing factor. There are exits front and back although by way of stairs. There are doors separating the stairways at the front but these are not rated doors. Further, there painted exit signs over the doors but they are not visible from the floor area. There are no exit signs to the rear stair.

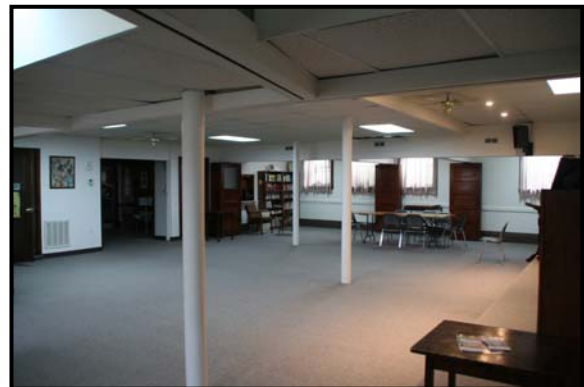
In the assembly hall in the basement, there are four steel posts supporting beams for the raked floor above to the northwest corner. There are three posts along the rear beam line and only one post along the front beam line. Because the nave floor is sloped towards the northwest corner, the framing of the floor appears to be in a radial nature with the three columns on an arc in the basement and then an additional column closer to the sanctuary corner.

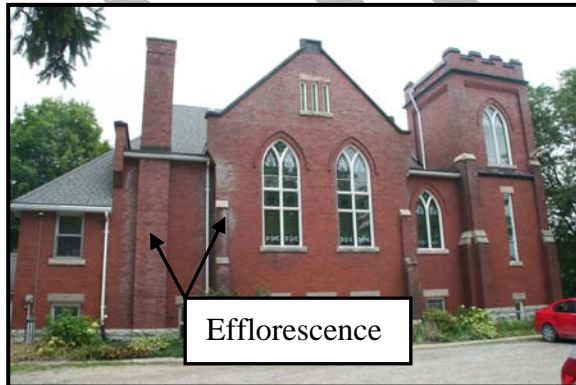
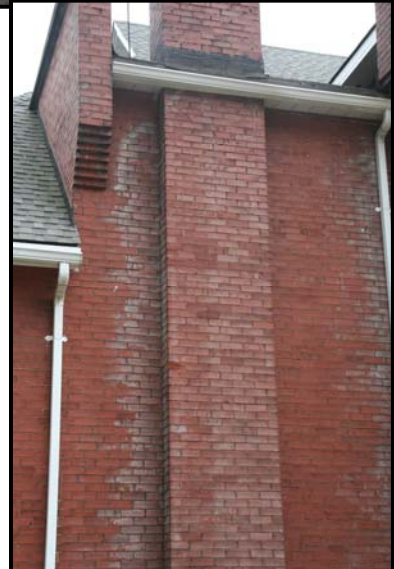
There is significant efflorescence on the west wall adjacent to one pilaster and over the chimney. The efflorescence at the chimney is due to water penetration through the soffit. Demolition of the chimney will eliminate this leakage. The pilaster is likely a function of overflow at the downspout requiring rework of the flashings around the downspout.
