Reference: 15-05-0071

Chalmers United Church  
842989 Road 84,  
Kintore, ON N0M 2C0

**RE: CONDITION ASSESSMENT**

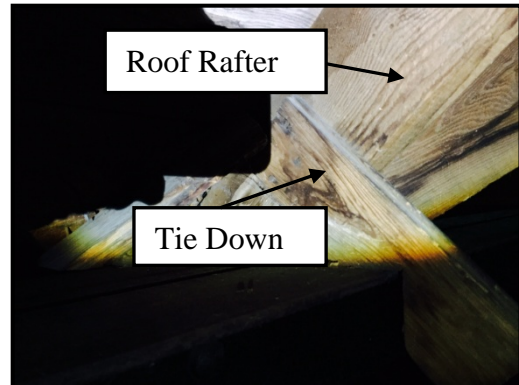
The valley rafters frame into a single roof rafter. The roof anchorage is accomplished by wood framing "hooked" over the steel girder.
